# Thermographic Survey Report

**Prepared for:**

Mr. Mark Huelin  
Airtight Solutions Ltd.  
Shenn Valley  
Ballakaighen  
Peel  
Isle of Man  
IM5 2AH

Thermographic images were taken of window and door details before and after the application of Quatro seal.

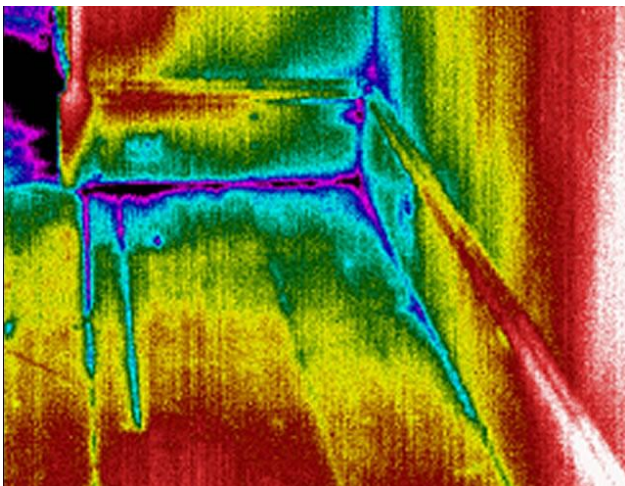
Before Quatro seal

Areas of cool air influx can be seen in the before image in dark blue and black colours at the skirting and floorboard detailing. The after image revealed far more consistent temperatures and colours. (The red/white warm area on the floor is caused by sunlight warming the floor)

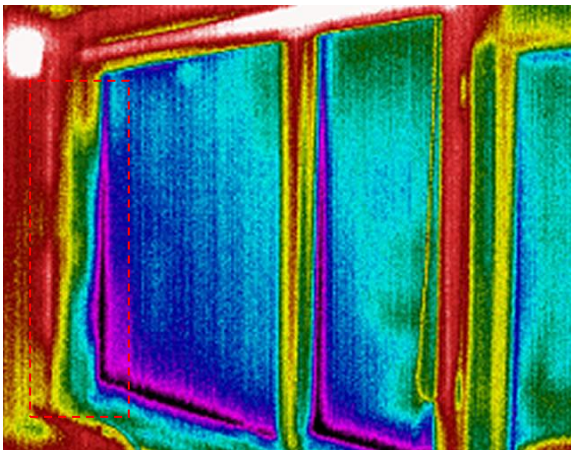
Before Quatro seal

The window detailing at the left side of this window showed cooler temperatures caused by cold air influx. This can be seen as dark blue and black colours at the left edge of the window frame. The after images show a much more consistent temperature and colour.

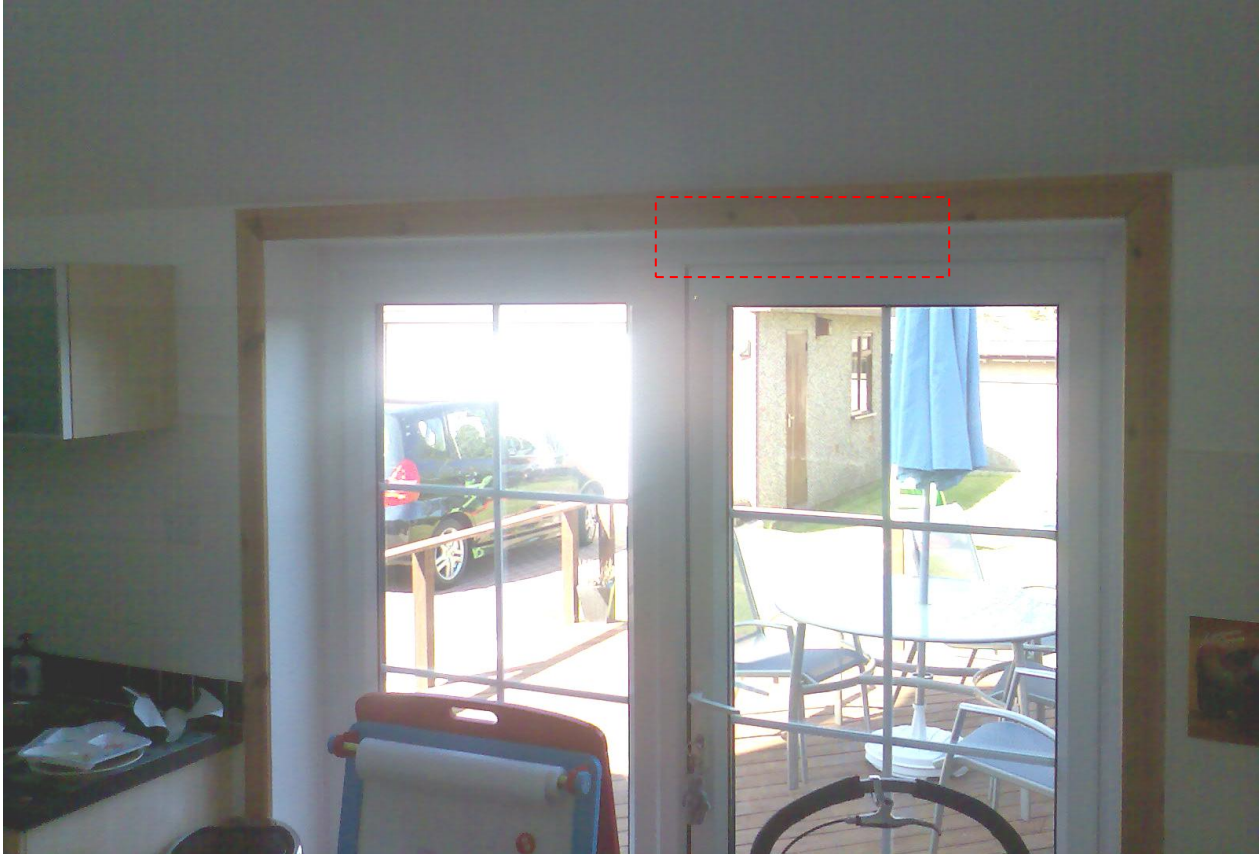
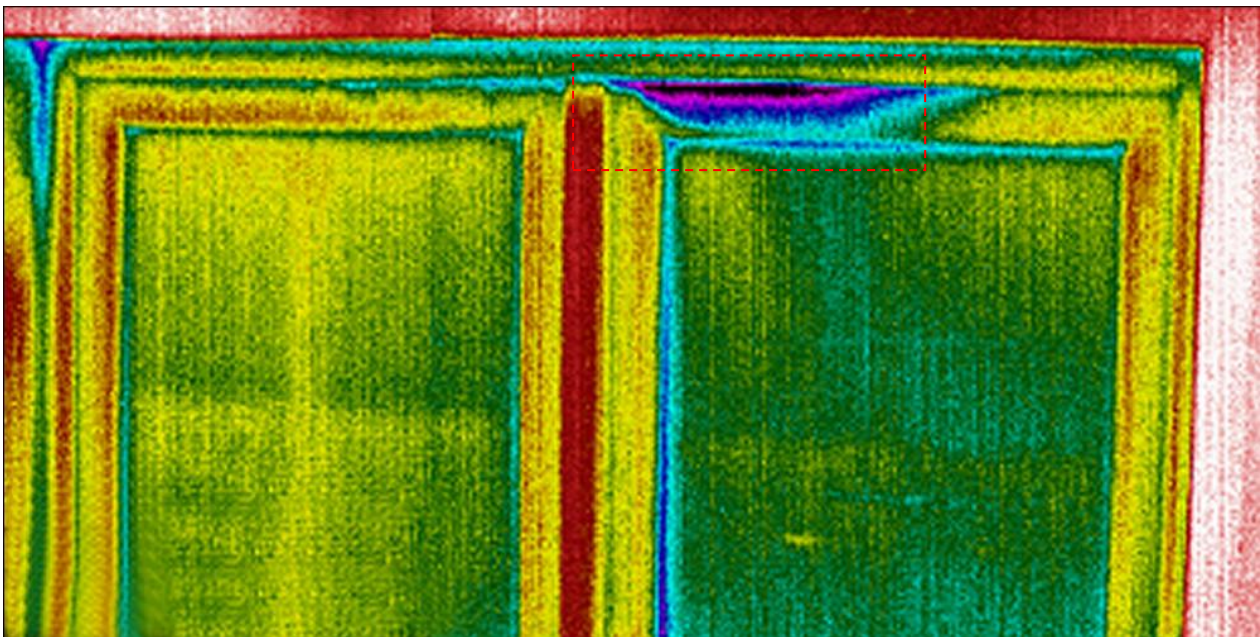
The above image shows French doors where the door on the left has been sealed using quatro seal and the door on the right has the original rubber seals. We can clearly see cool air entering at the original door seal in dark blue and purple colours.
